AIRCRAFT ACCIDENT INVESTIGATION REPORT

China Airlines
Airbus Industrie A300B4-622R, B1816
Nagoya Airport
April 26, 1994

July 19, 1996

Aircraft Accident Investigation Commission
Ministry of Transport

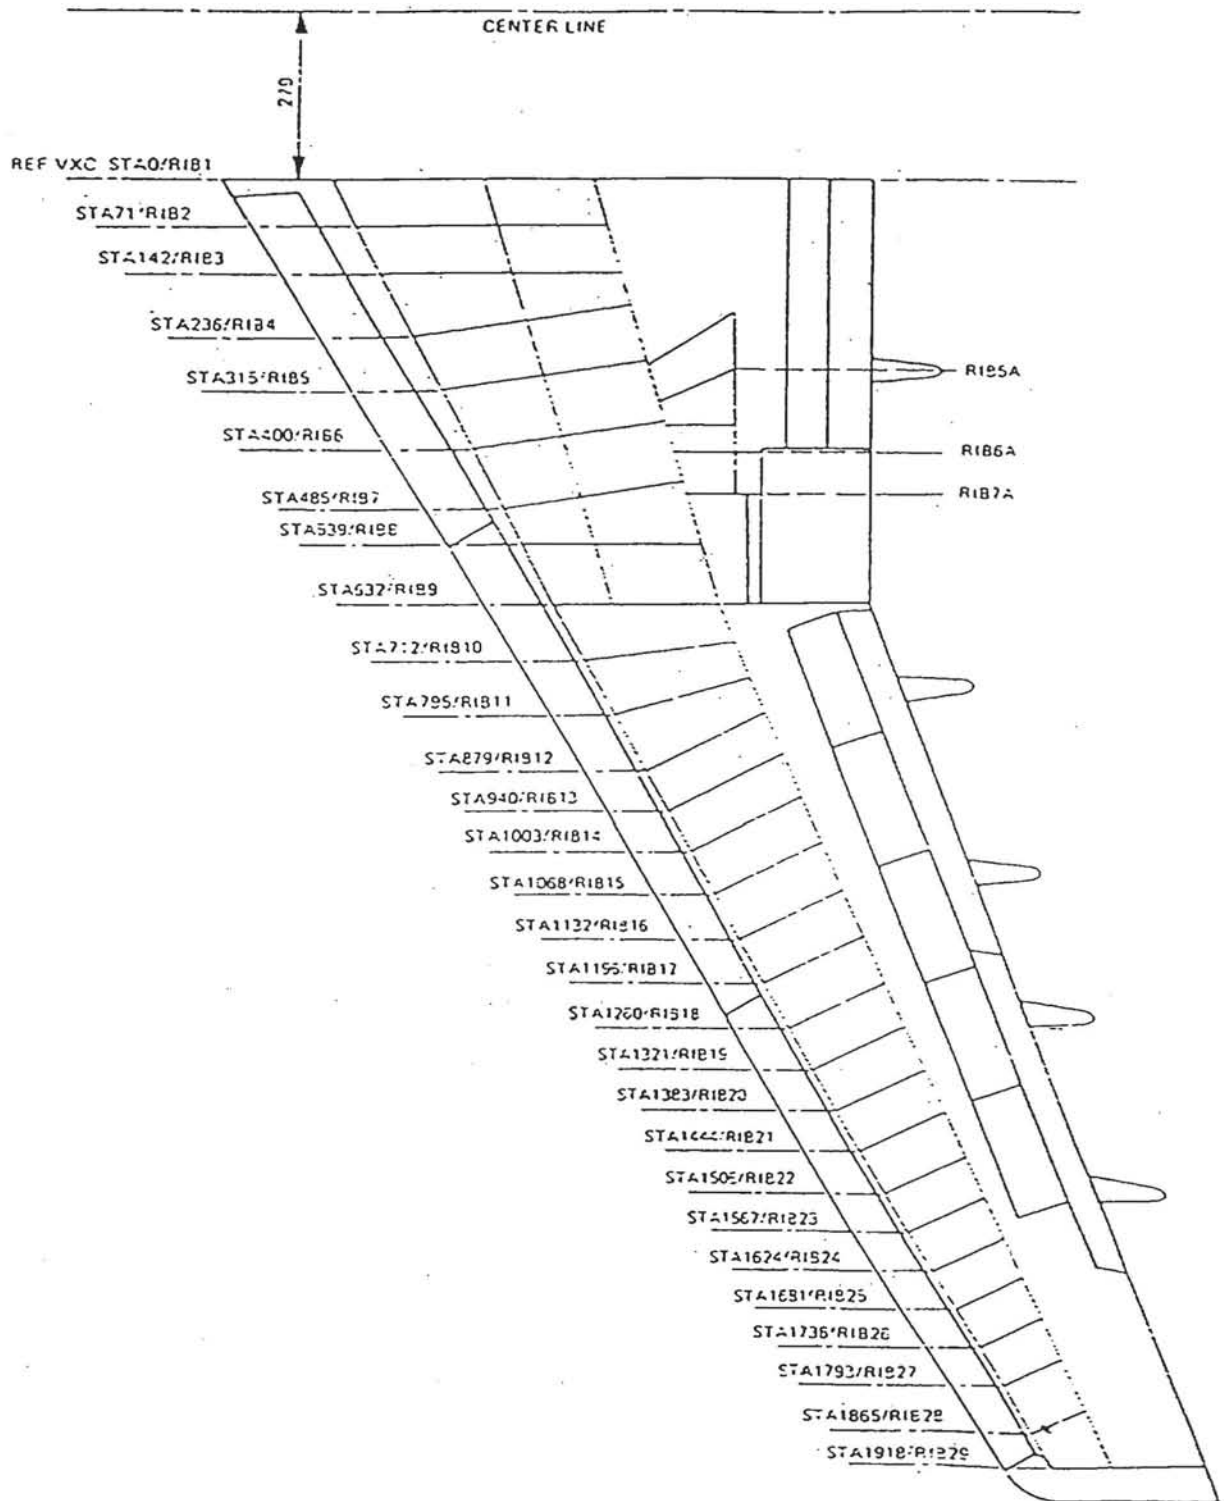
Attached Figure 19 Wing Stations

- ③ Center box section
 - The center box section was burnt.
 - Almost all thrust work ribs of the center-box lower structure had buckled and fractured by an upward force (see attached Figure 19).

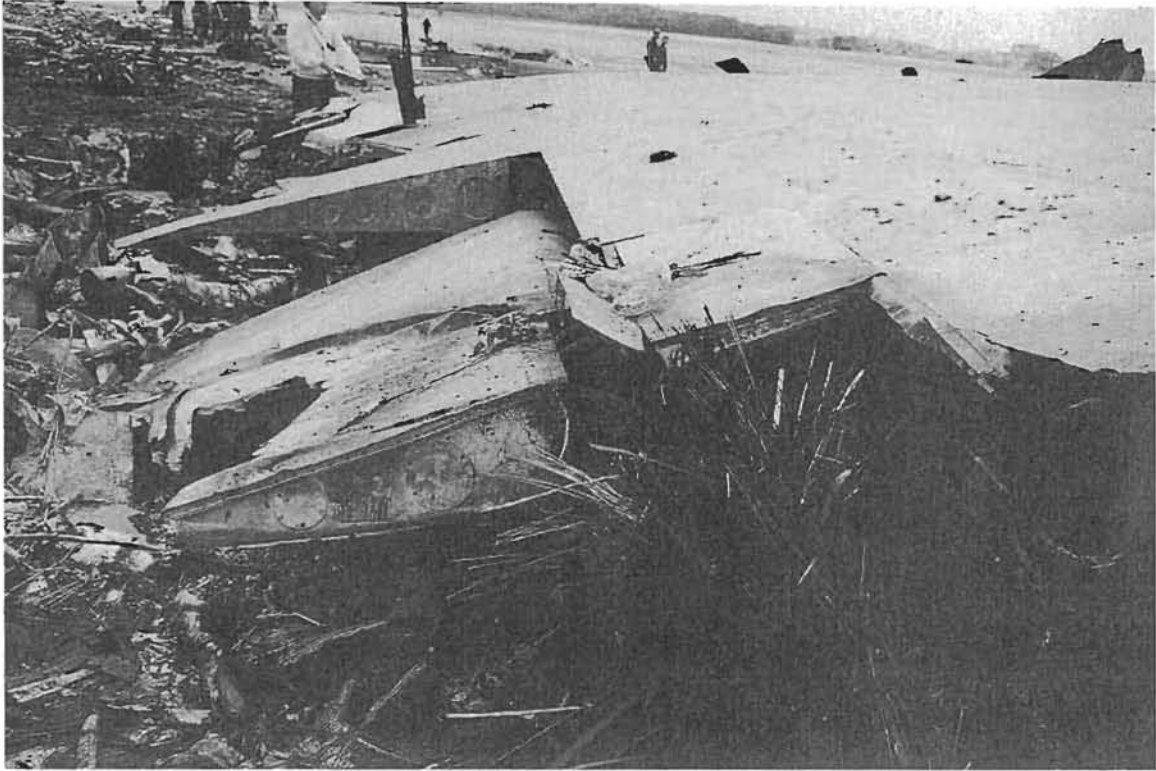
Photo.5 Left Aileron

Both the RH and LH ailerons were in their down positions and were burnt.
(See attached Photographs 5 and 6)

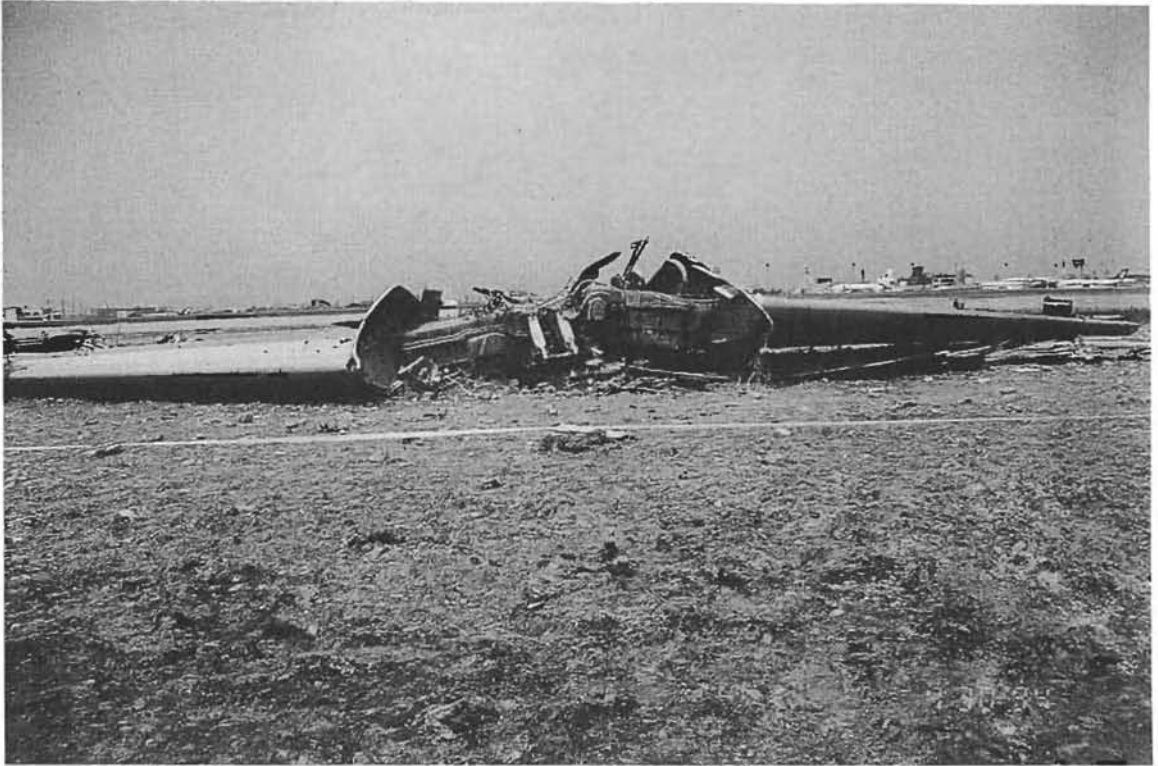
Photo.11 THS

- The THS had separated at its joint to the fuselage, and was fractured at its central section.
- The screw jack was fractured and had torn off at the screw shaft section near the actuator's bottom end; it was bent near the nut.

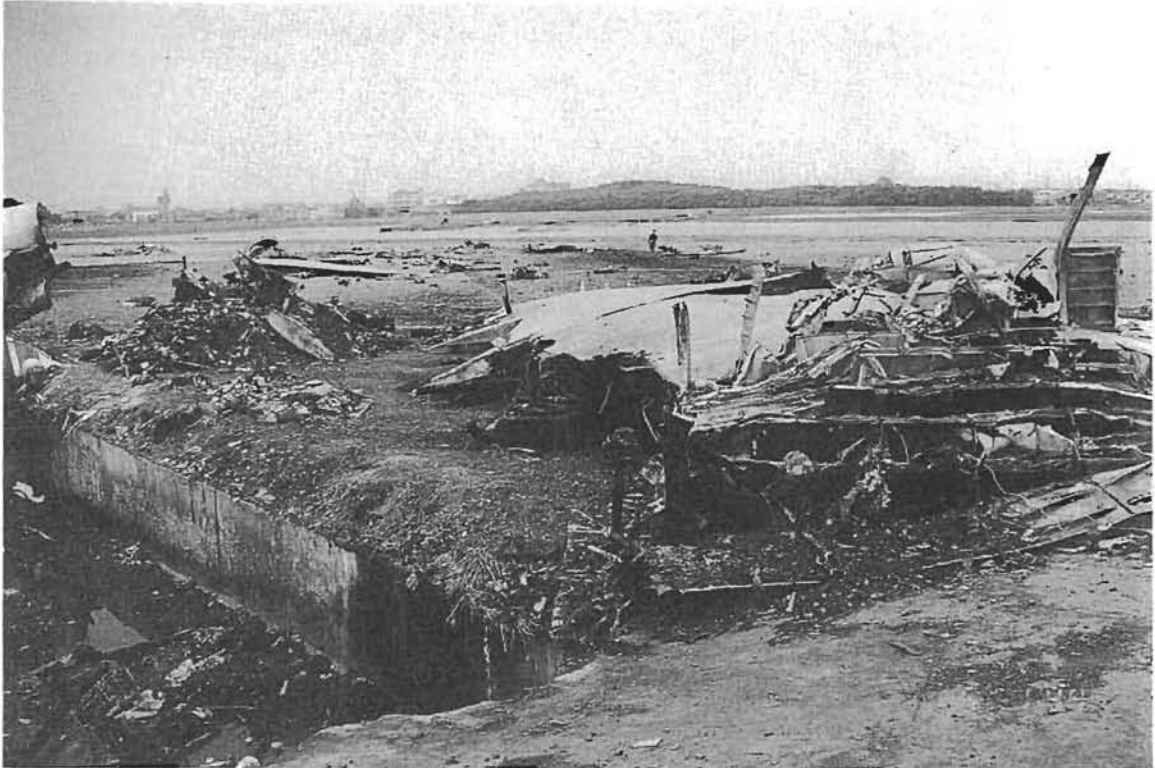
Photo.19 Left Wing

- ① LH wing
 - The main spar and upper skin in the upper section of the pylon (between W.STA 400 and 485) were fractured.
 - The skin in the rear part of the aft main spar, on the inboard side of the aileron, was destroyed by fire.
 - The lower skin had been exposed to flames and was burnt.
 - The upper skin between W.STA 940/RIB 13 and W.STA 1567/ RIB 23 had melted.
 - The wing tip was fractured near W.STA 1567/RIB 23, and had separated from the main wing and burnt.
 - The tip fence was fractured and burnt, and had separated with its lower part deformed. (See attached Photograph 19)

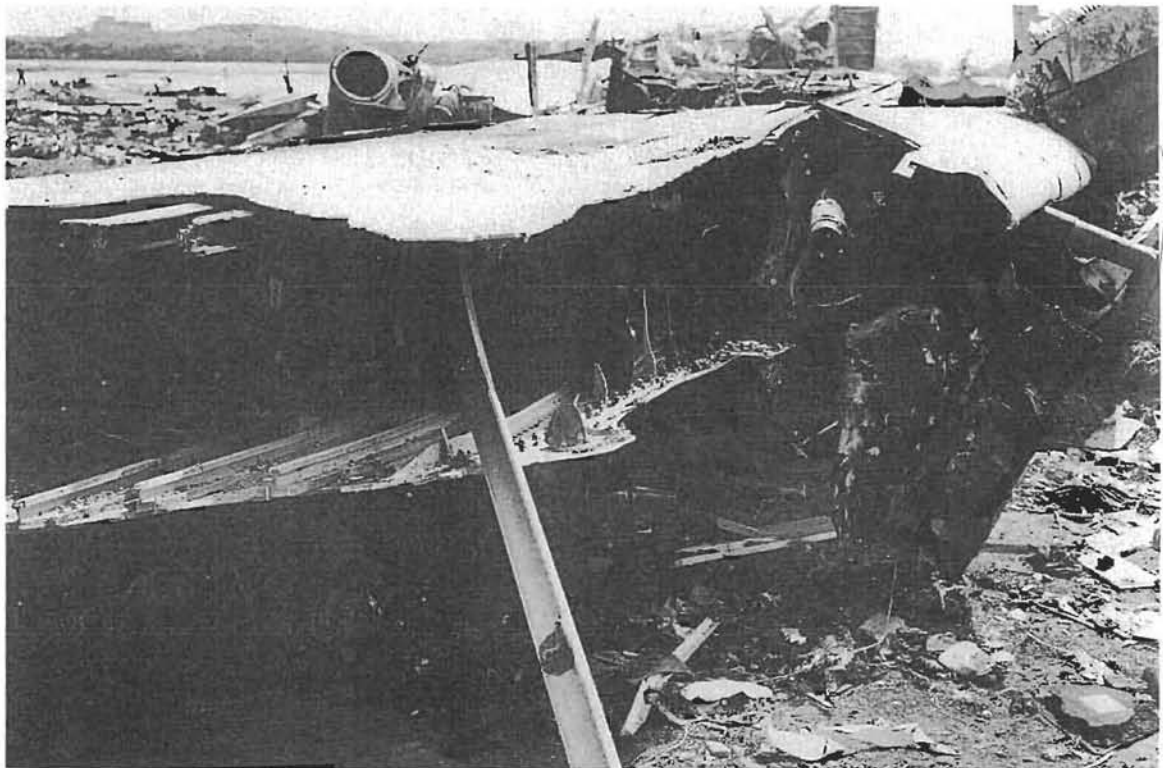
Photo.20 Fractures of the Right Wing

- ② RH wing
 - Almost all portions of the leading edge located on the inboard side of the No. 2 engine pylon were destroyed by fire.
 - The skin in the rear part of the aft main spar, inboard the aileron, was partly destroyed by fire.
 - The upper skin and the aft main spar near W.STA 879/RIB 12 were cracked.
 - The RH wing was fractured and had torn off near W.STA 1132/ RIB 16; the detached wing outboard structure had fragmented into small pieces, some of which were burnt.
 - The wing tip was fractured, had torn off near W.STA 1624/RIB 24, and was burnt.
 - Tip fence was fractured and had torn off with its top deformed. (See attached Photograph 20)

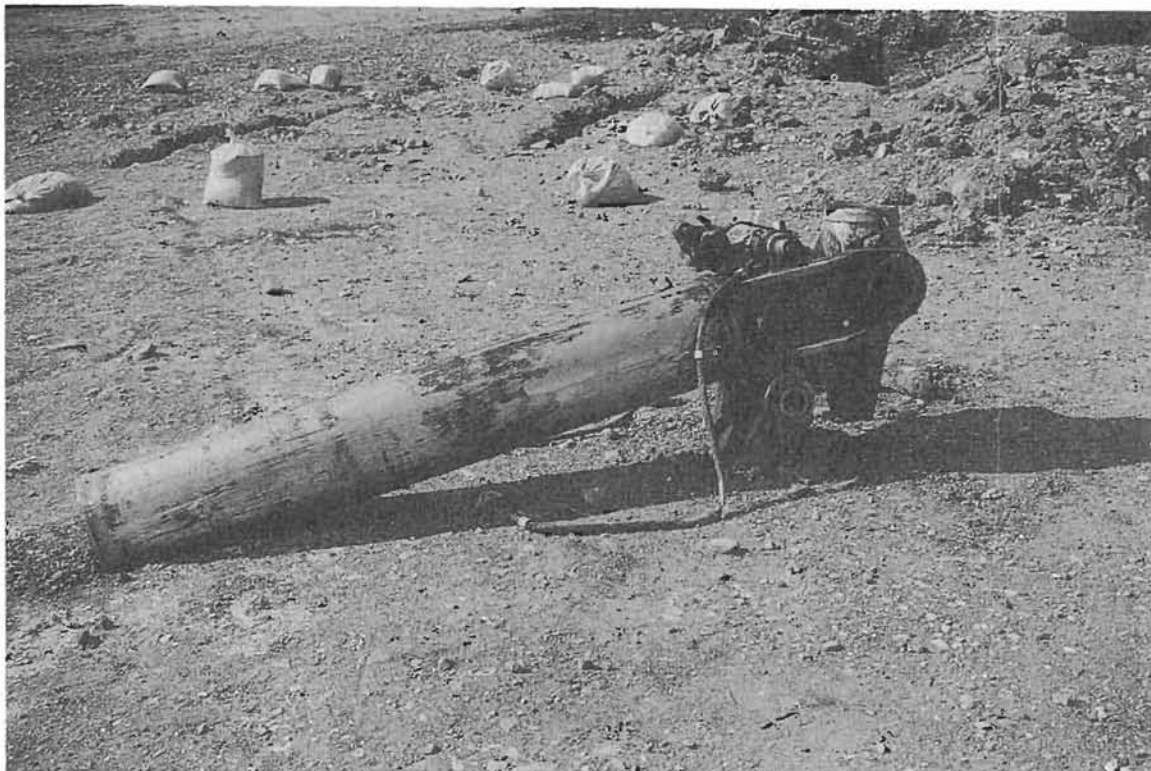
Photo.21 Shock Absorber of the Left Main Landing Gear

- The upper section of the shock strut was fractured, and had broken off and burnt.
- Fractured drag strut and torque link remained attached to the lower section of the shock strut.
- The shock strut was fractured; its upper section was partly burnt and had been detached with the actuating cylinder, fractured drag strut and other parts still attached to it.

- The wing side rear mount was fractured and remained attached to the aft hinge point in the upper section of the shock strut.
- The shock absorber had been displaced from the shock strut and was detached.

- The shock absorber contained pieces of the fractured bogey beam and torque link still attached to it.
- The shock absorber's piston was detached from the cylinder.

- No. 1 and No. 5 tires were burnt.
(See attached Photographs 21 and 22)

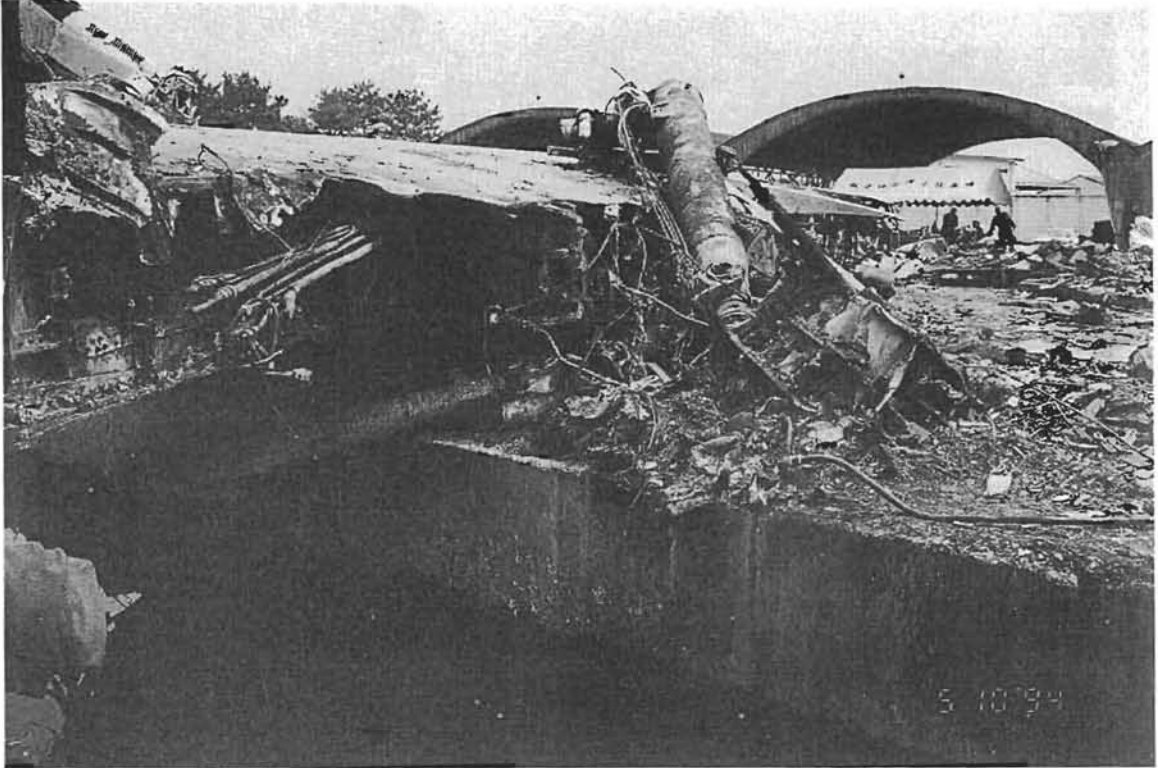
Photo.23 Shock Strut of the Right Main Landing Gear

- The shock strut was partly burnt and detached, with parts including the actuating cylinder and fractured drag strut, etc, still attached to its upper section.

- The drag strut, torque link, and part of the folding brace strut, all fractured, remained attached to the lower section of the shock strut.
- The shock strut rear mount, fractured and detached from the wing, remained attached to the aft hinge point in the upper section of the shock strut.

- The shock absorber had been displaced from the shock strut and was detached.
- The shock absorber had the fractured bogey beam and pieces of torque link still attached to it.

- The shock absorber's piston had torn off.
- The folding brace had a fractured lower strut, and was burnt and detached with a part of airframe structural element still attached to it.

- The No. 7 and No. 8 brakes, as well as the corresponding tires and wheels (two each) were burnt in an assembled state.
- The No. 3 and No. 4 tires had burst, and the No. 4 tires were burnt.
(See attached Photographs 23 and 24)

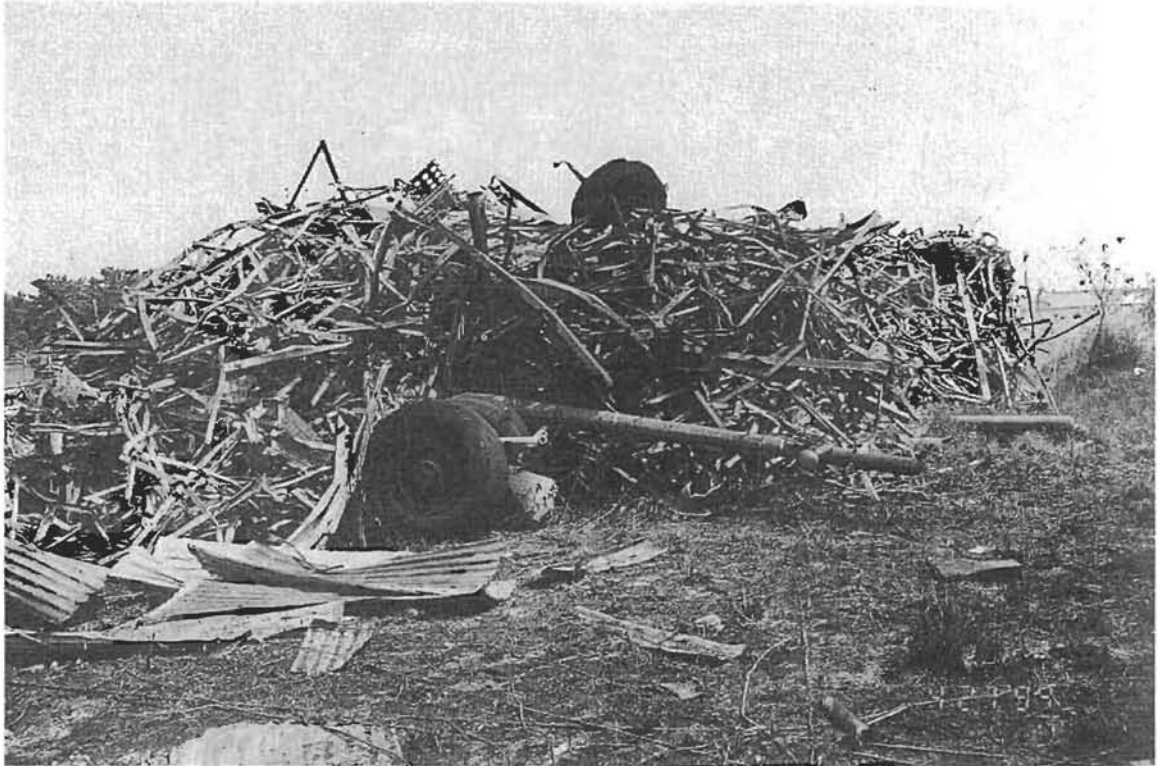
Photo.24 Tires of the Right Main Landing Gear

- The bogey beam was fractured at both its front and rear sections. The No. 3 and No. 4 brake assemblies of the front section had come off their axles, and the tires and wheels were detached and destroyed.
