# Medical Devices: The Therac-25\*

Nancy Leveson  
University of Washington

## 1 Introduction

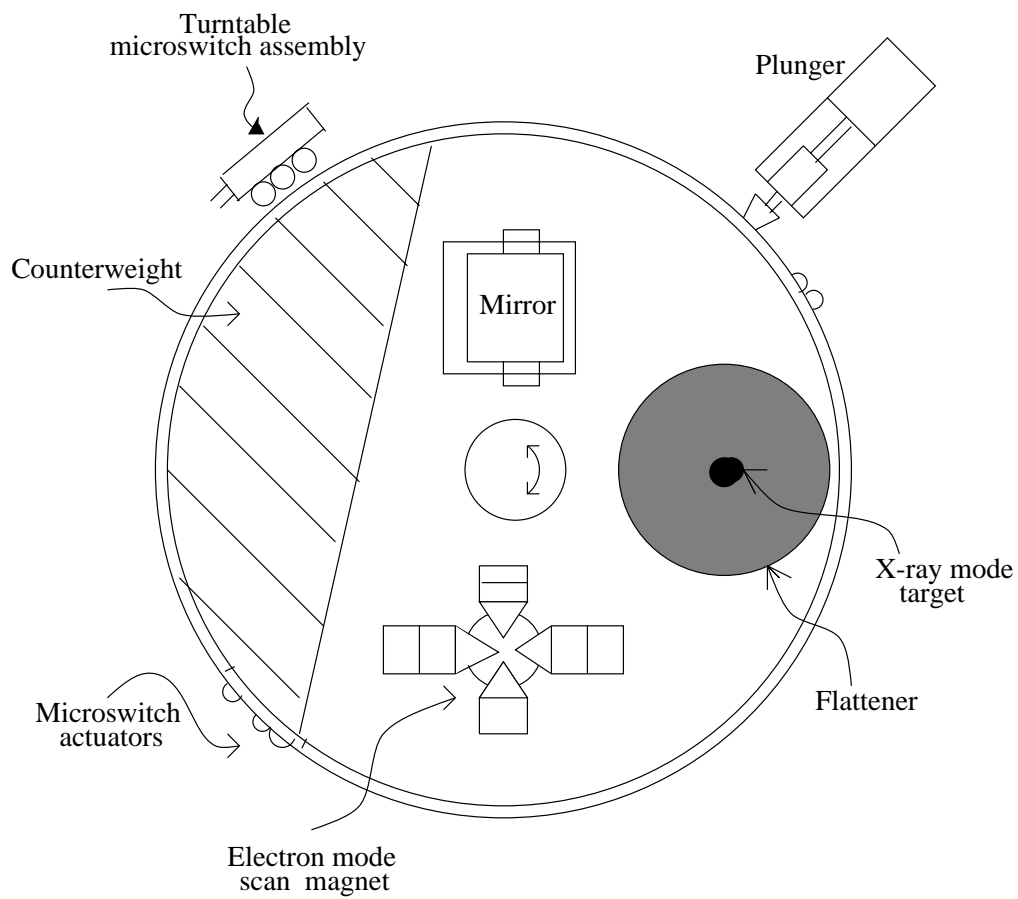
Figure 1: Upper turntable assembly.

**Turntable Positioning.** The Therac-25 turntable design plays an important role in the accidents. The upper turntable (see Figure 1) rotates accessory equipment into the beam path to produce two therapeutic modes: electron mode and photon mode. A third position (called the field light position) involves no beam at all, but rather is used to facilitate correct positioning of the patient. Because the accessories appropriate to each mode

are physically attached to the turntable, proper operation of the Therac-25 is heavily dependent on the turntable position, which is monitored by three microswitches.

The computer senses and controls turntable position by reading a 3-bit signal about the status of three microswitches in the turntable switch assembly. Essentially, AECL determined that a 1-bit error in the microswitch codes (which could be caused by a single open-circuit fault on the switch lines) could produce an ambiguous position message to the computer. The problem was exacerbated by the design of the mechanism that extends a plunger to lock the turntable when it is in one of the three cardinal positions: The plunger could be extended when the turntable was way out of position, thus giving a second false position indication. AECL devised a method to indicate turntable position that tolerated a 1-bit error so that the code would still unambiguously reveal correct position with any one microswitch failure.

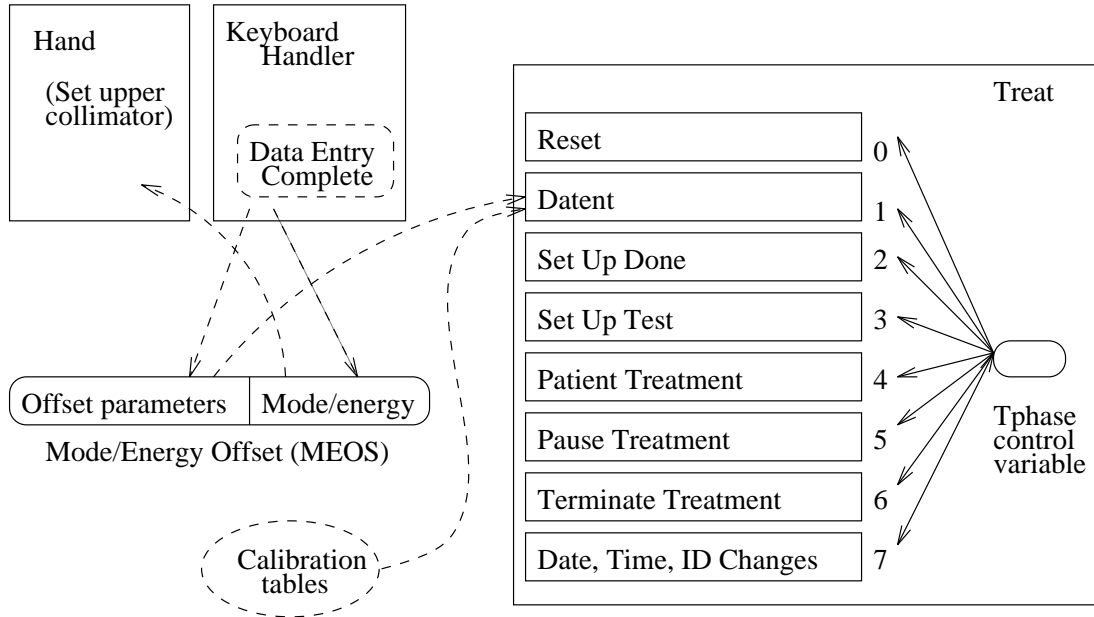
Figure 3: Tasks and subroutines in the code blamed for the Tyler accidents.

The treatment monitor task (Treat) controls the various phases of treatment by executing its eight subroutines. The treatment phase indicator variable (Tphase) is used to determine which subroutine should be executed (Figure 3). Following the execution of a particular subroutine, Treat reschedules itself.

But this is not the only problem. Upon exit from the Magnet subroutine, the data entry subroutine (Datent) checks the Data Entry Complete variable. If it indicates that data entry is complete, Datent sets Tphase to 3 and Datent is not entered again. If it is not set, Datent leaves Tphase unchanged, which means it will eventually be rescheduled. But the Data Entry Complete variable only indicates that the cursor has been down to the command line, not that it is still there. A potential race condition is set up. To fix this, AECL introduced another shared variable controlled by the keyboard handler task that indicates the cursor is not positioned on the command line. If this variable is set, then prescription entry is still in progress and the value of Tphase is left unchanged.

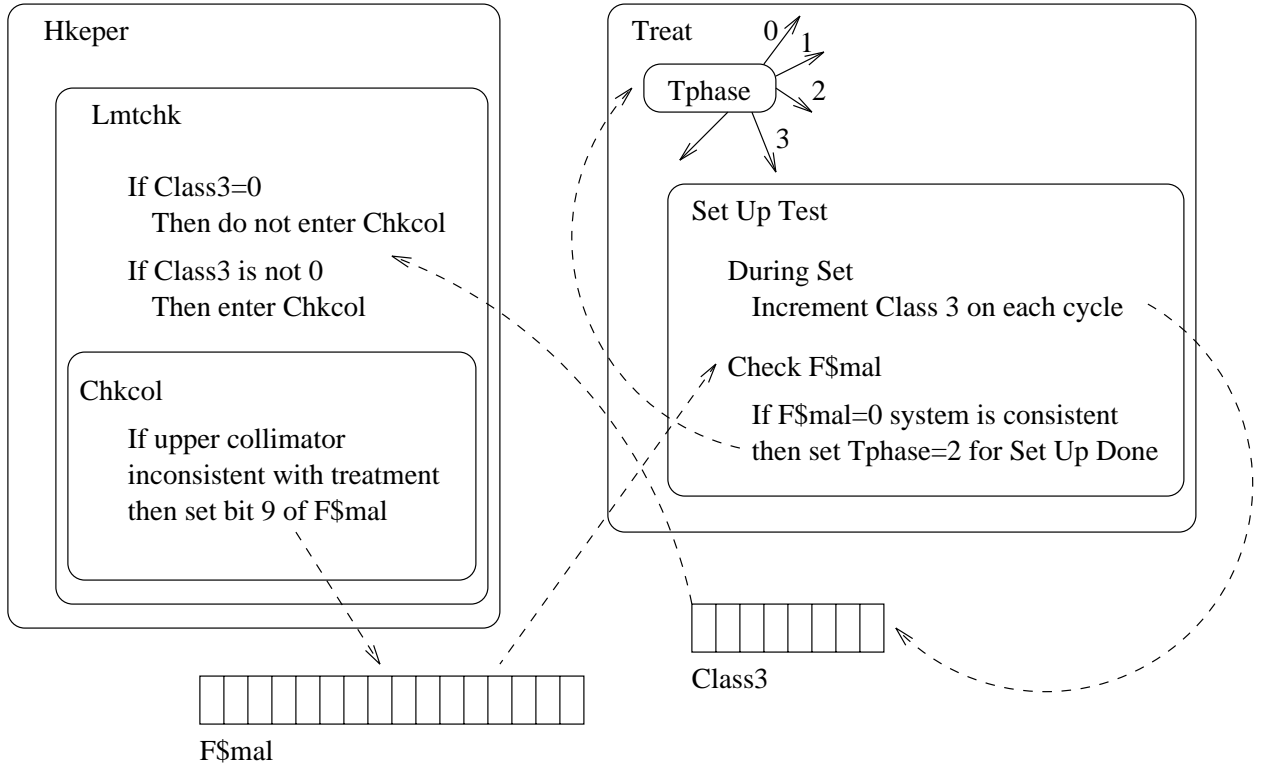
Figure 4: The Yakima software flaw.

The second Yakima accident was again attributed to a type of race condition in the software — this one allowed the device to be activated in an error setting (a “failure” of a software interlock). The Tyler accidents were related to problems in the data-entry routines that allowed the code to proceed to Set Up Test before the full prescription had been entered and acted upon. The Yakima accident involved problems encountered later in the logic after the treatment monitor Treat reaches Set Up Test.

The overexposure occurred when the operator hit the “set” button at the precise moment that Class3 rolled over to zero. Thus, Chkcol was not executed and F\$mal was not set to indicate that the upper collimator was still in the field-light position. The software turned on the full 25 MeV without the target in place and without scanning. A highly concentrated electron beam resulted, which was scattered and deflected by the stainless
