AIRCRAFT ACCIDENT INVESTIGATION REPORT

China Airlines
Airbus Industrie A300B4-622R, B1816
Nagoya Airport
April 26, 1994

July 19, 1996

Aircraft Accident Investigation Commission
Ministry of Transport

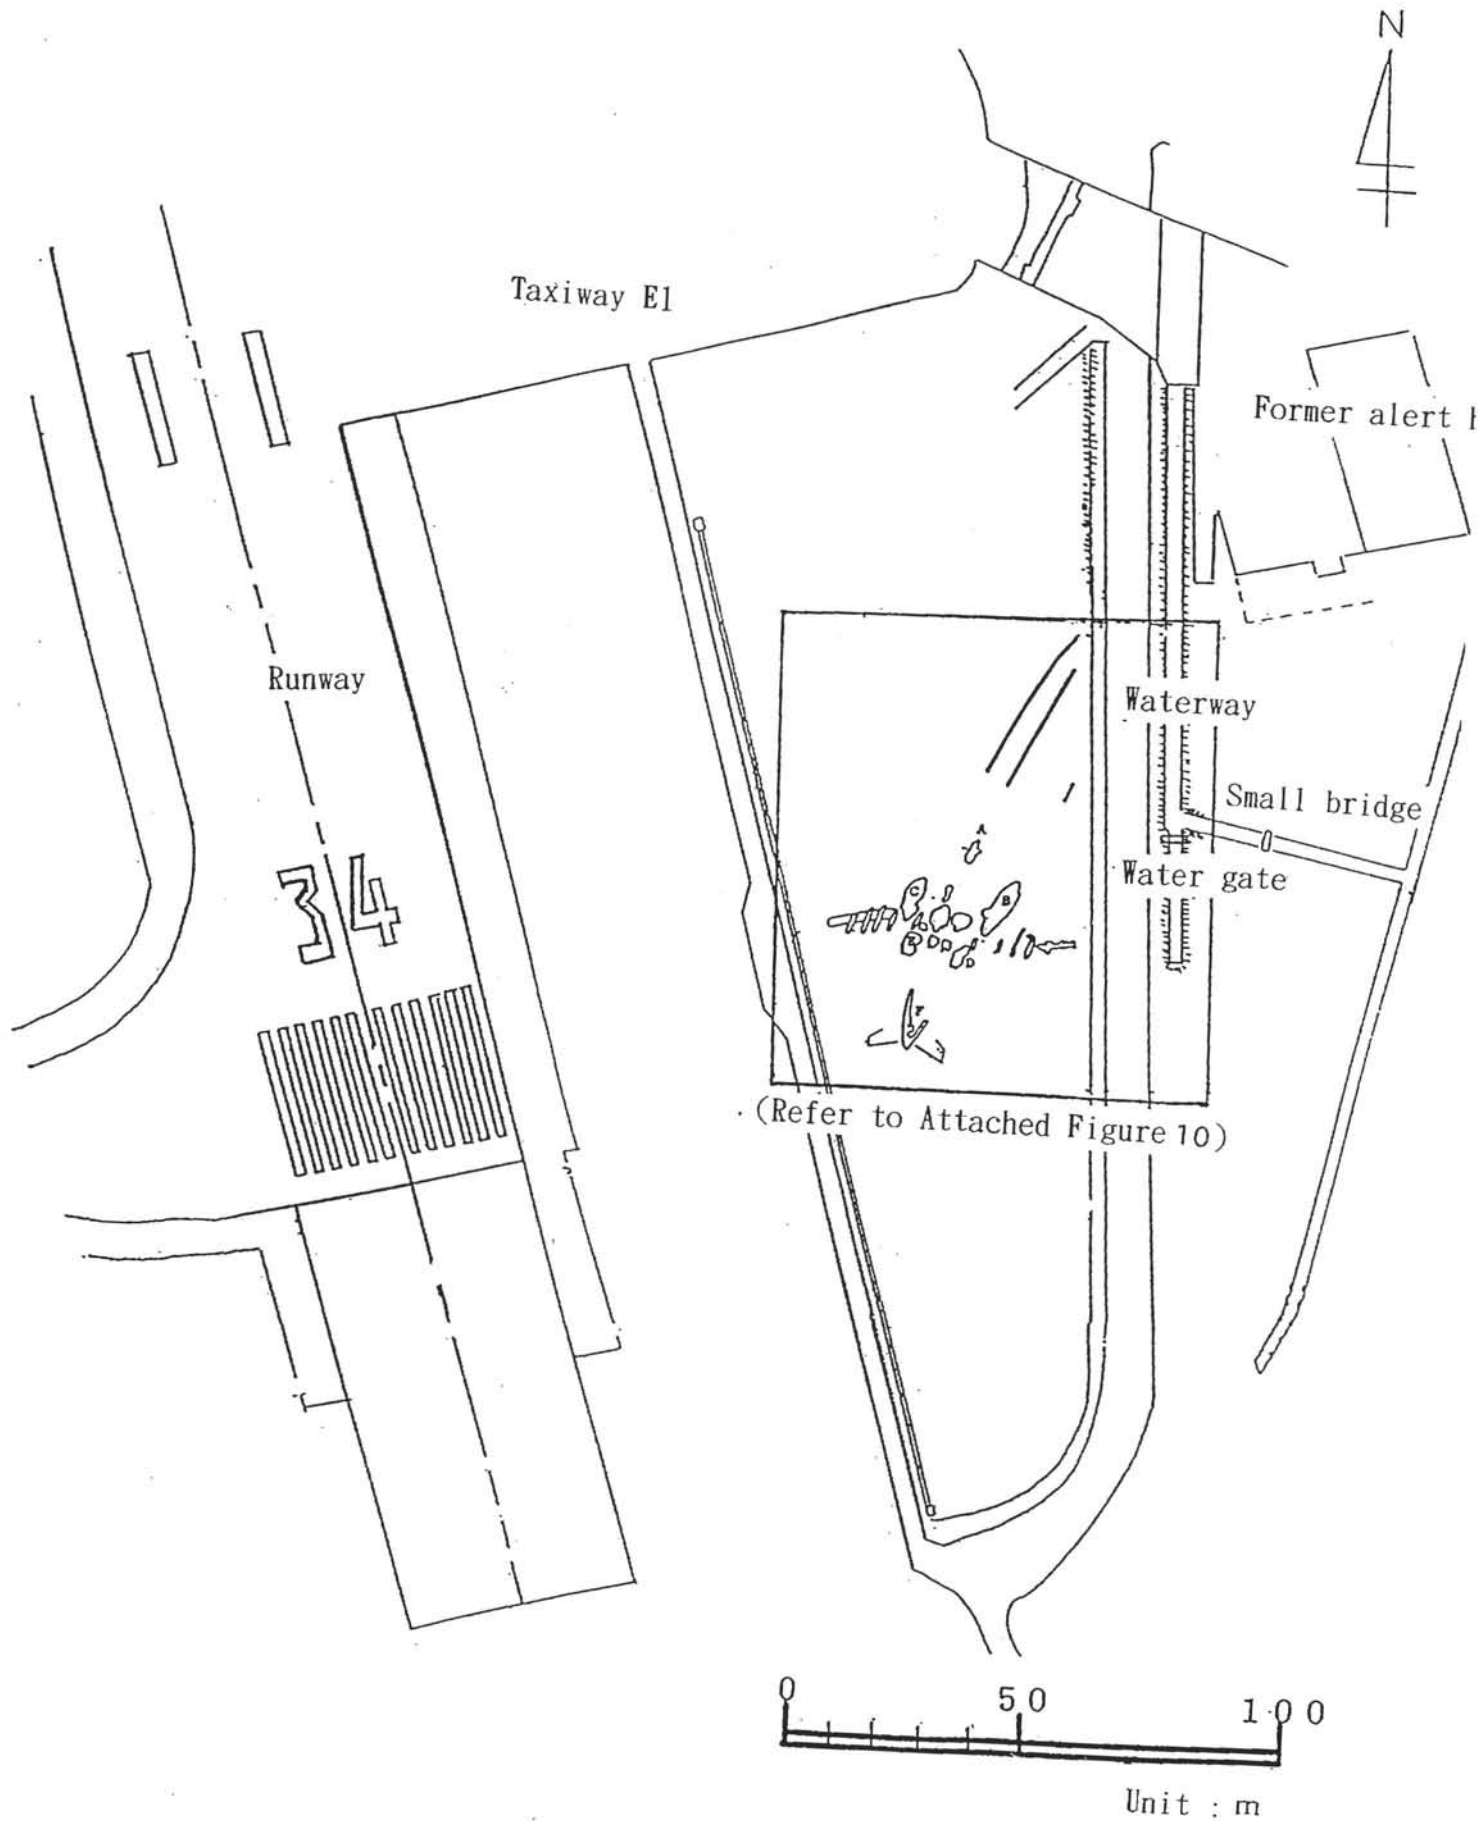
Attached Figure 9 Sketch of Wreckage on the Ground after the Crash

The direction of the linear marks which are made when the center section of the fuselage scratched the ground, coincided with magnetic bearing of about 22°. (See attached Figures 9, 10, and Photographs 49 and 50.)

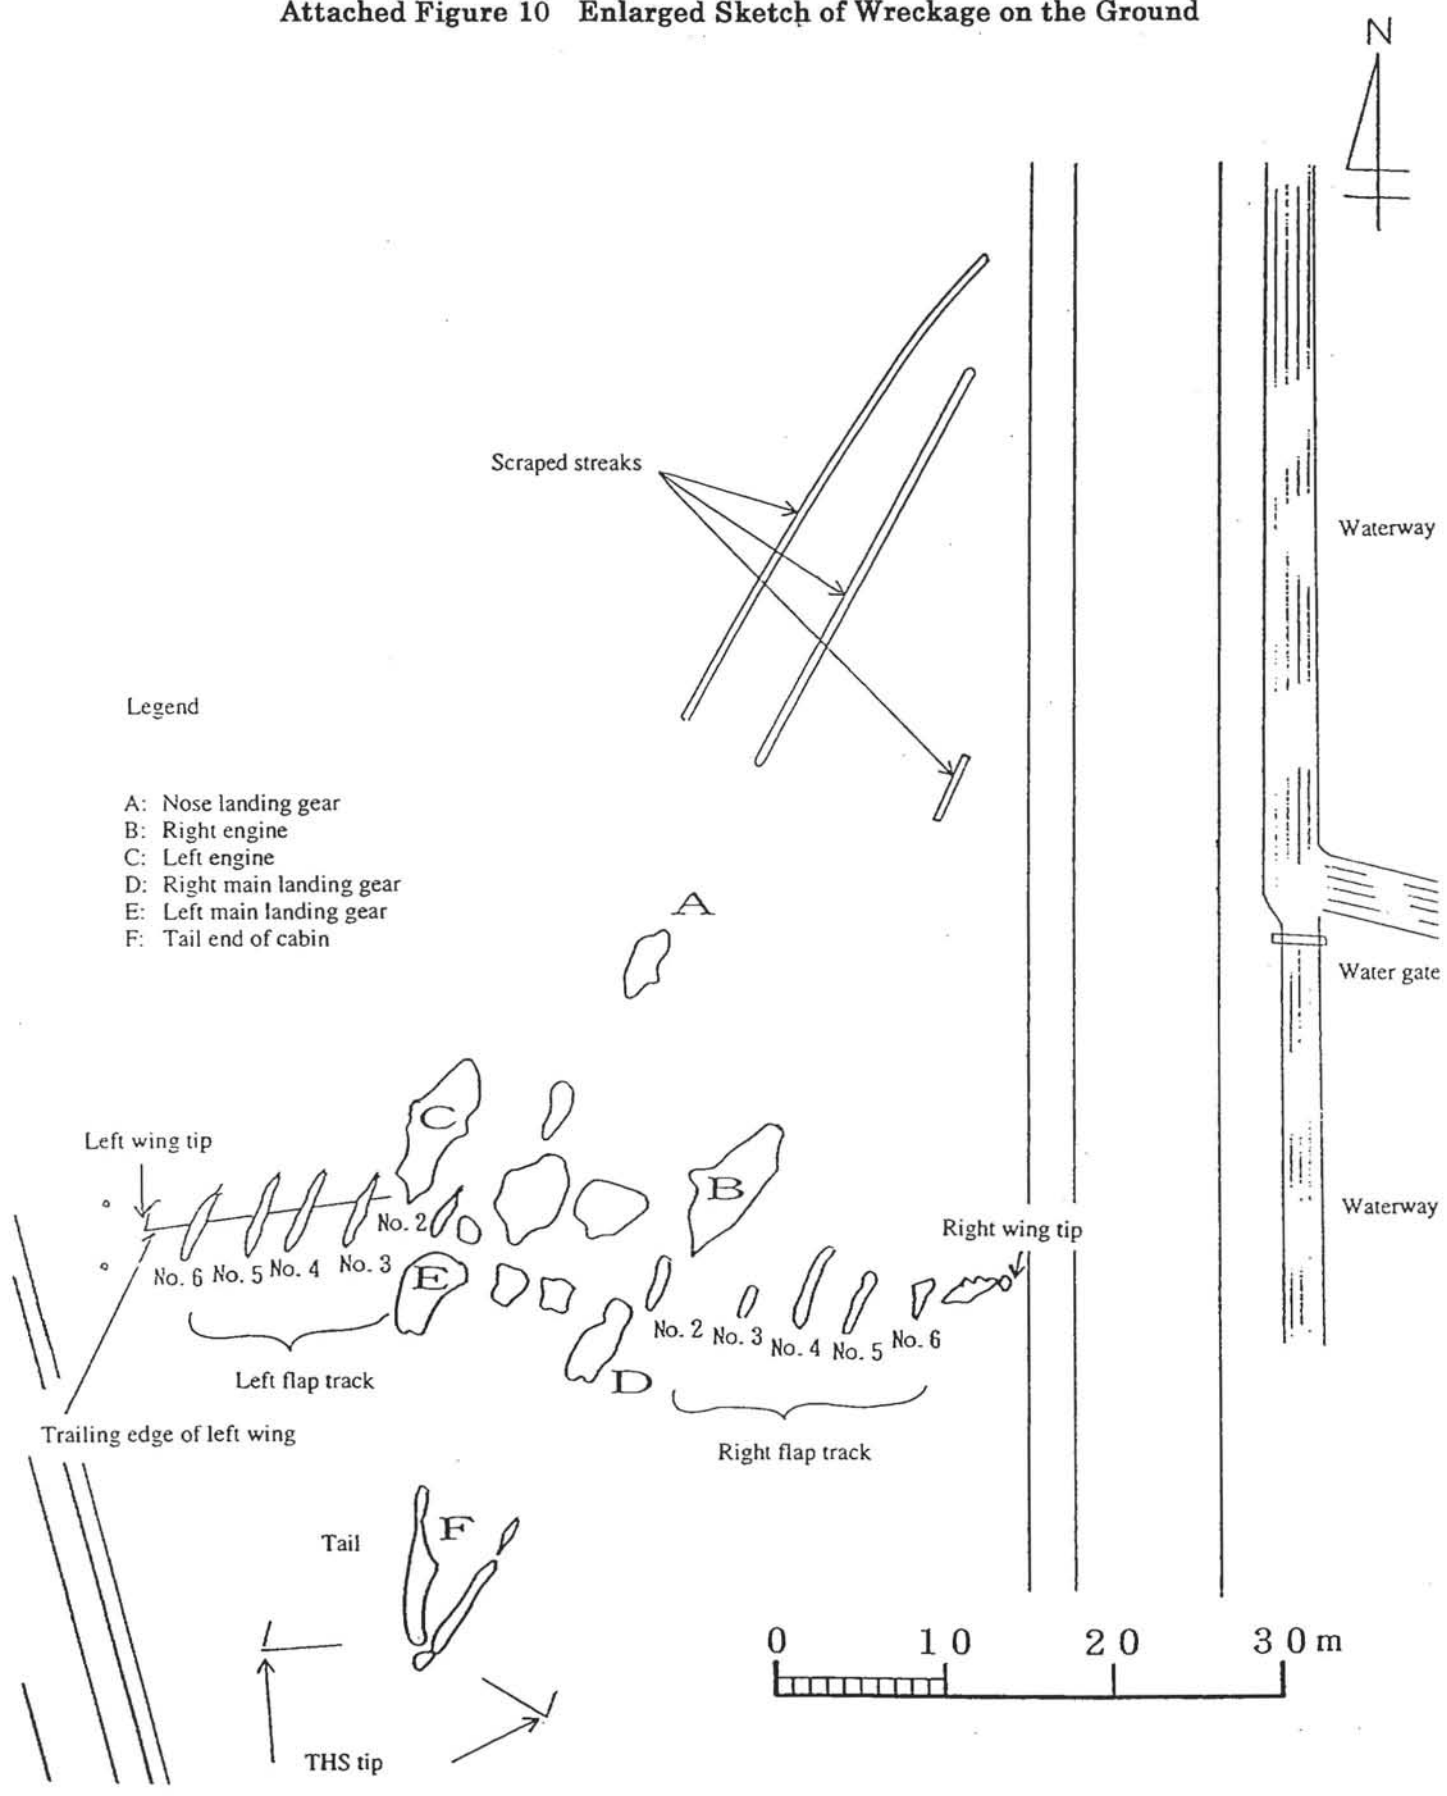
Attached Figure 10 Enlarged Sketch of Wreckage on the Ground

The positions of the marks left by the nose landing gear, LH and RH main landing gears, LH and RH engines, LH and RH wingtips, and THS are as shown in attached Figure 10.

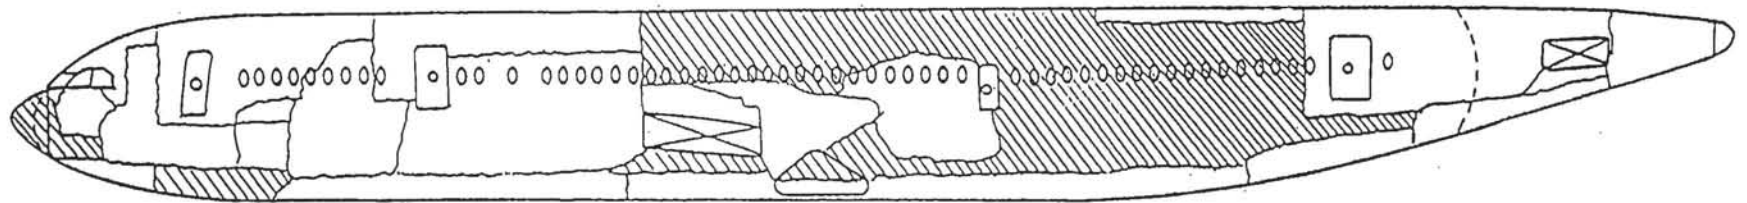
Attached Figure 13 State of Damage to Fuselage Skin

State of Breakage in Left Fuselage

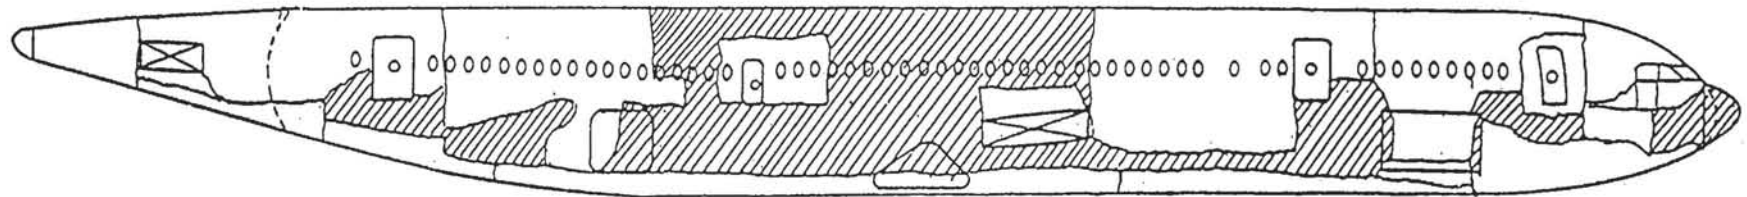
State of Breakage in Right Fuselage

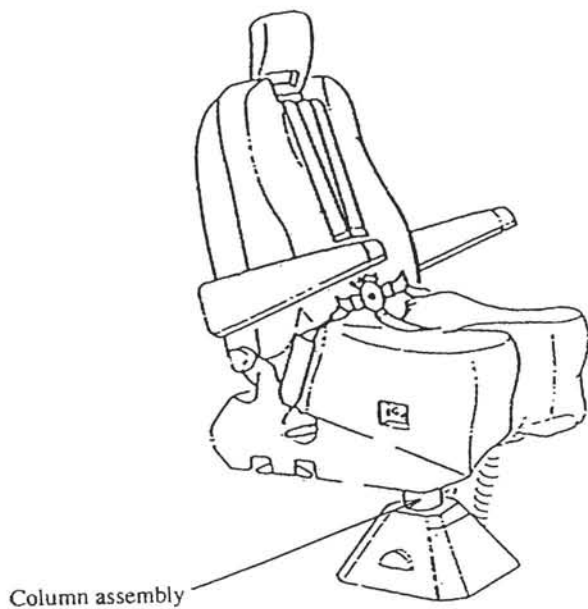
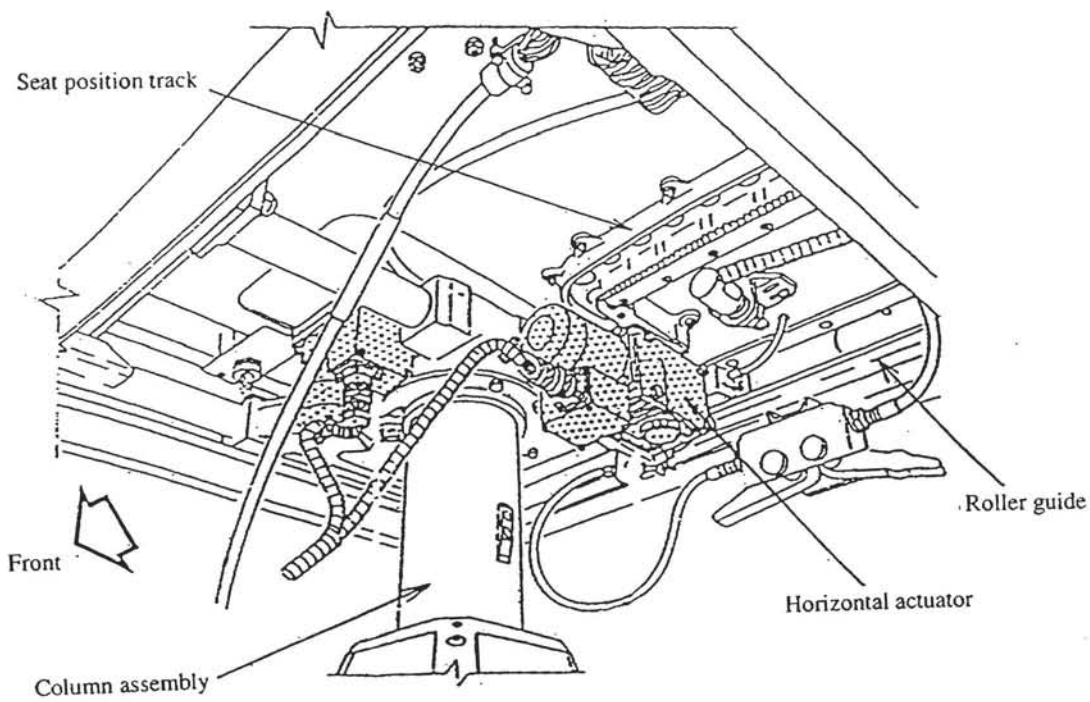
Attached Figure 24 External View of Pilot's Seat

According to their airman medical certificates, the CAP and the F/O were 162.5 cm and 178.1 cm tall, respectively. (See attached Figures 24 and 25.)

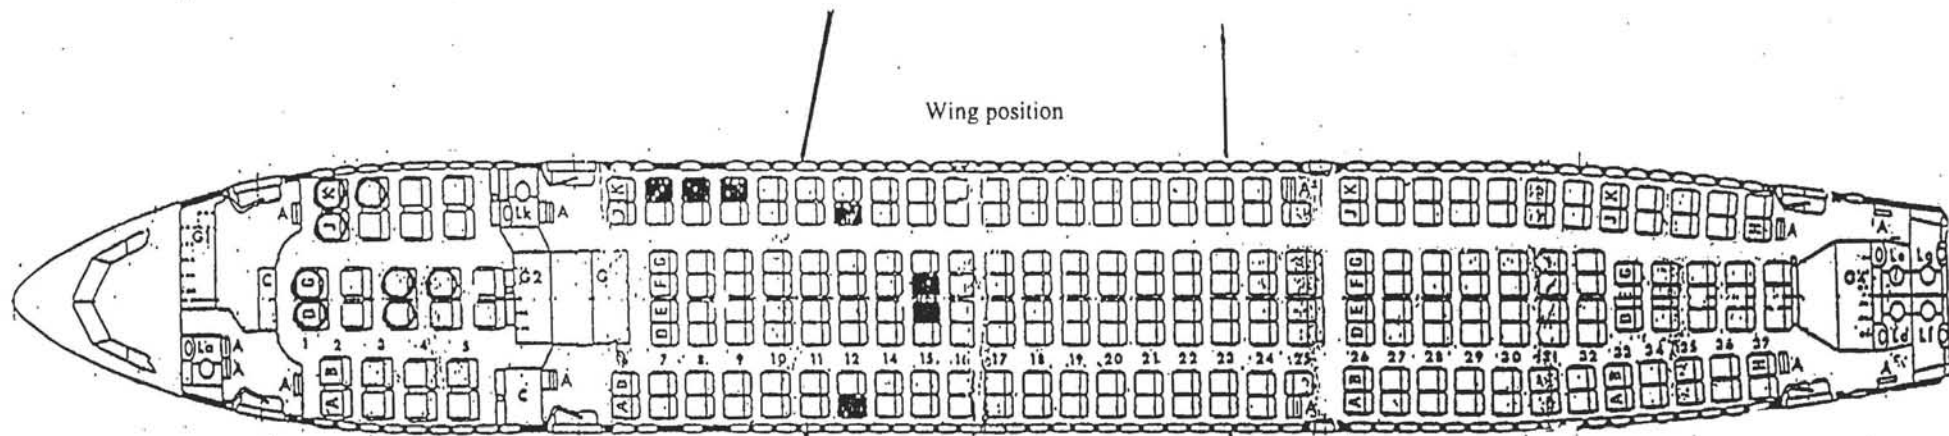
Attached Figure 26 Seat Arrangement Chart

✱ ■ seats occupied by survivors.

○ seats were not occupied. The rest of seats were occupied by the deceased.

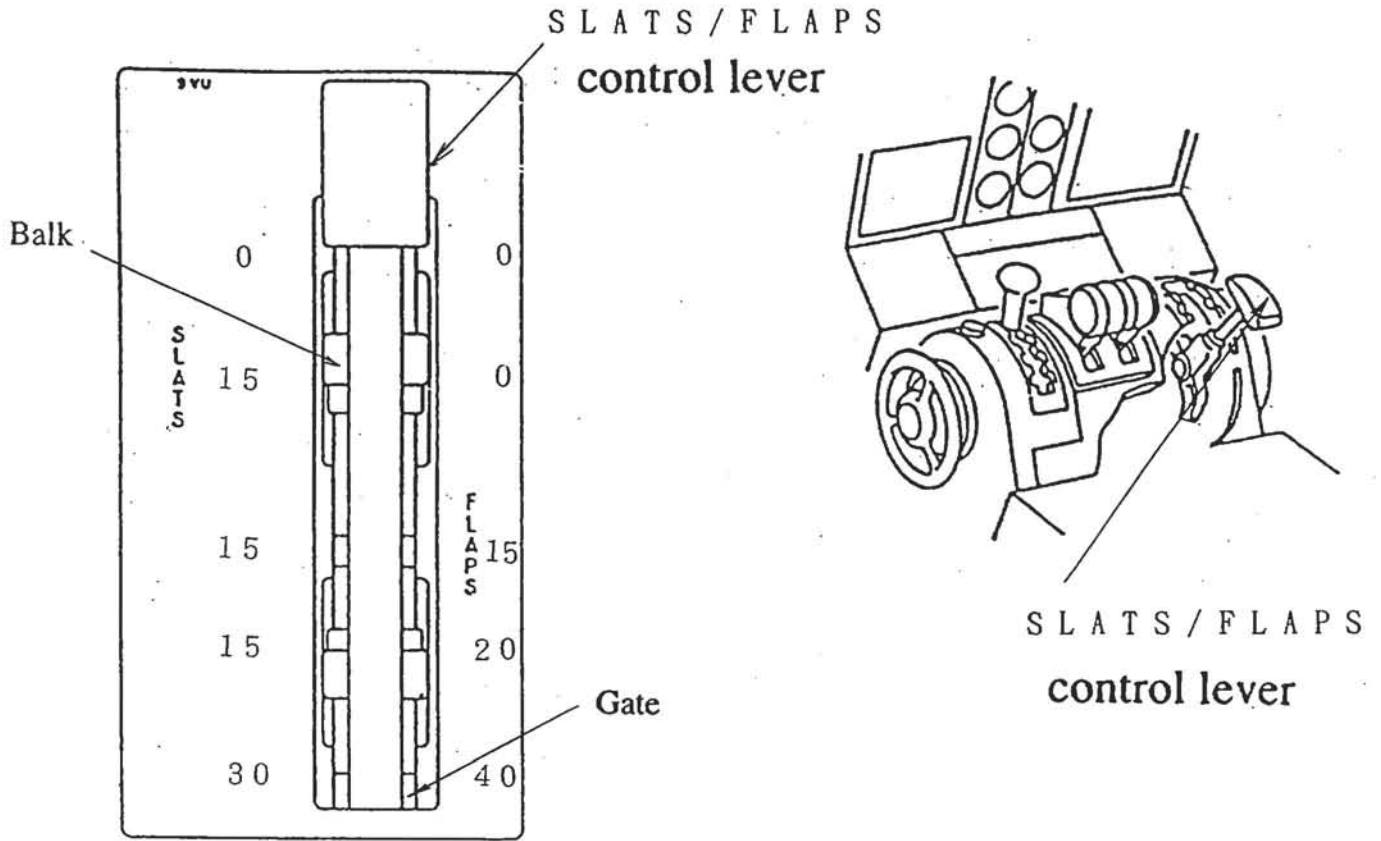
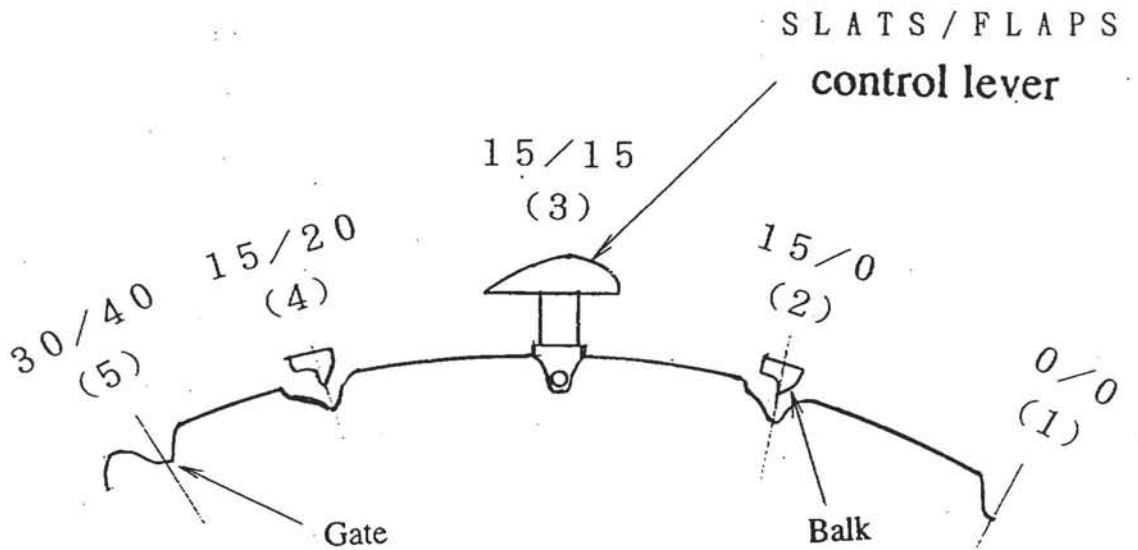
Attached Figure 27 Sketch of SLATS/FLAPS Control Lever Gate and Balk

- 1115:18 The sound indicating passage of the SLATS/FLAPS lever through the baulk attached gates was recorded twice (see attached Figure 27).
According to normal go-around procedure, the SLATS/FLAPS lever should be moved from the 30/40 position one step higher to 15/20. However, judging from the numbers of times the SLATS/FLAPS lever sound was recorded, it may have been moved beyond the 15/20 position, perhaps to the even higher 15/0, or 0/0 position. Later, at 15:27, a sound presumably indicating the SLATS/FLAPS lever's downward movement passing through the baulk attached gate was recorded on the CVR. Also on the DFDR is a record showing that the SLATS/FLAPS lever was set on the 15/15 position at 1115:28.

While the SLATS/FLAPS lever should be moved from 30/40 to 15/20, from the CVR record it is considered possible that the lever was moved to 15/0 or even higher, to the 0/0, before being lowered again to the 15/15 position. The landing gears were left in the down position (See attached Figure 27.).

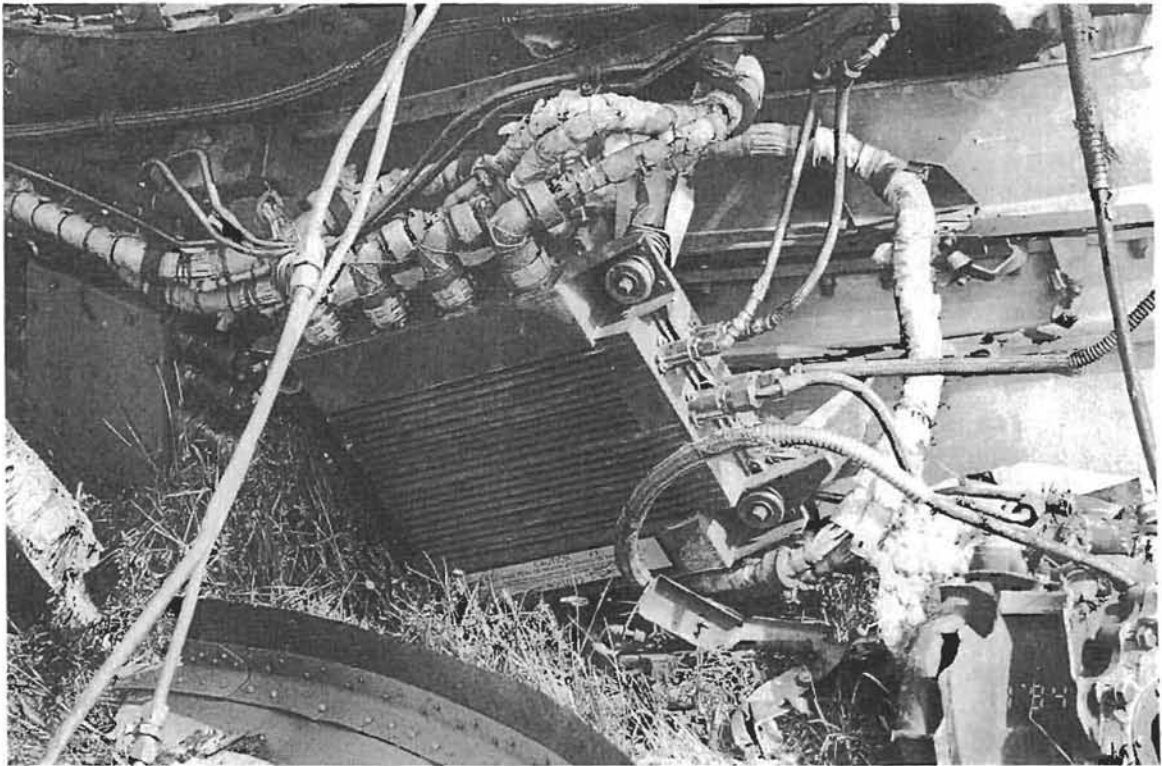
Photo.32 No.1 Engine FADEC

The FADECs had a dual system consisting of channels A and B. Their disassembly inspection showed that the processor boards for both channels in each FADEC were in good conditions. The fault memories storing the engine control failure condition records were readable on all the channels. As a result of the analysis of these records, evidence of surges which indicate a rapid drop of pressure in the engine combustor in flight before crash, was detected in channels A and B of the FADEC for both engines (See Photograph 32).

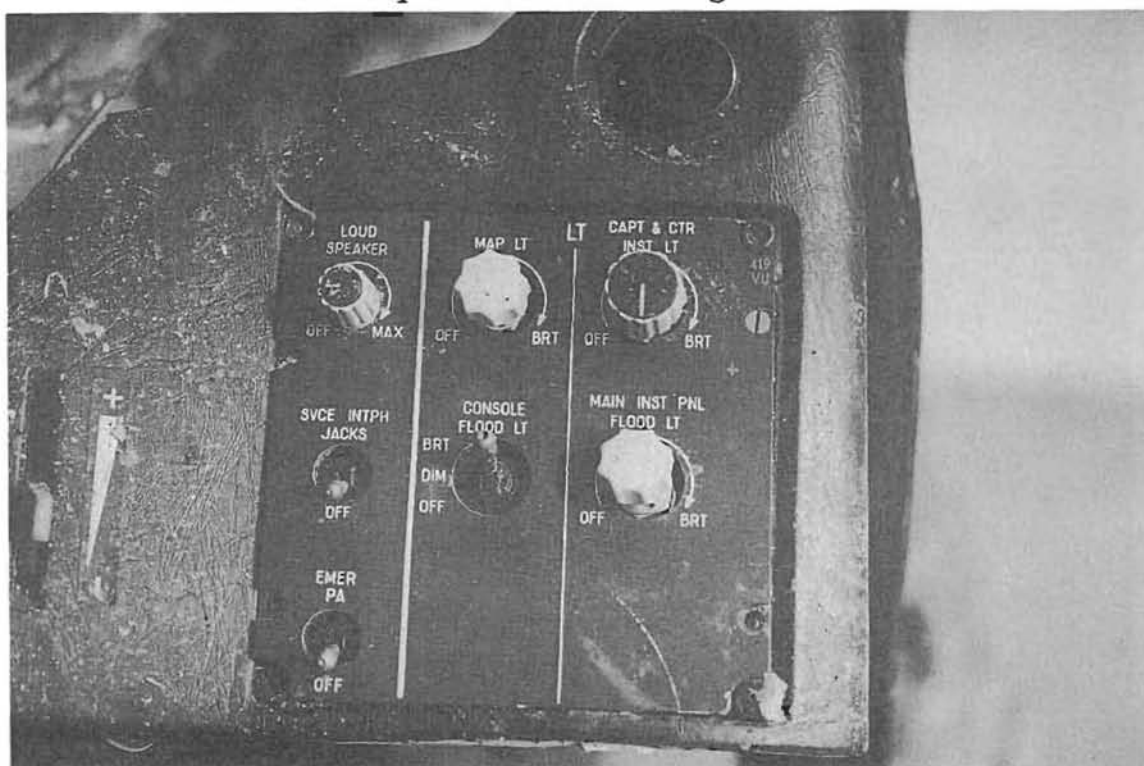
Photo.42 Captain and Center Light Panel

- (3) From the conversation between the CAP and F/O, recorded on CVR, about control of a light, it is recognized that the CAP was adjusting a light (refer to attached Figure 23).

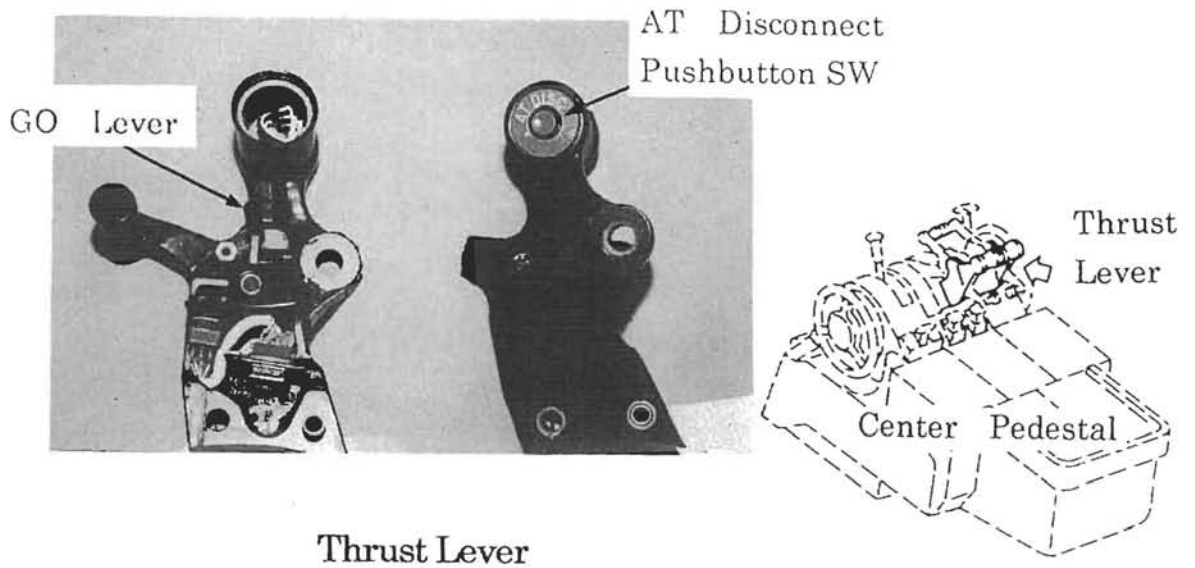
Photo.51 GO Lever Alignment with Thrust Lever

The GO lever of the A300-600R type aircraft is positioned below the thrust lever knob. The direction that the GO lever is operated in is the same as the direction in which the thrust lever is retarded, or as the same direction that the fingers move when gripping the thrust lever knob. With this arrangement, the possibility exists for an inadvertent activation of the GO lever during normal operation of the thrust levers (See attached Photograph 51).
