The Back Bay:

Winning the Battle, Losing the Water

2003 - Grant Jordan - 11.016

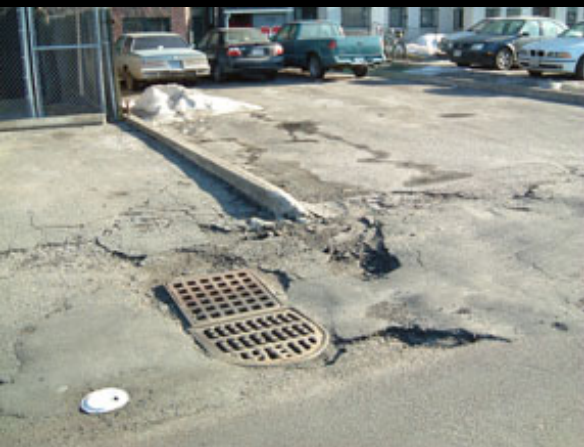
Parking lot with extra drain, showing massive water damage to asphalt.

The problem of drainage is felt throughout the Back Bay. Because much of the area is sloped toward the Charles, sites on the north end of the Back Bay receive far more water after storms. The parking lot shown provides a good example of this. It lies on the far north end of the Back Bay and thus receives a disproportionate amount of runoff. So much more water flows there than was expected by the builders that they had to put in a second drain at the low point of the lot. This particular lot also shows evidence of damage to the asphalt due to water. When drainage is insufficient, water pools around the drains. Some of it gets into the asphalt, then freezes, cracking the surface of the lot. The process then repeats over time, making cracks larger and potholes deeper. The builders in this case forgot to take into account not just the amount of rain that will fall on this area, but the water that naturally flows to the area as well. Similar situations are seen throughout the Back Bay, contributing to the decline of the street and alley surfaces of the area. In the case shown at left, the drainage was properly planned for when the building was first constructed, but when the storm sewer system changed years later, it was plugged and never replaced. The result is a low-lying area in an alley that fills to about 6-inches of water whenever it rains. An example of the fact that even good planning in the past cannot make up for poor planning in the present.

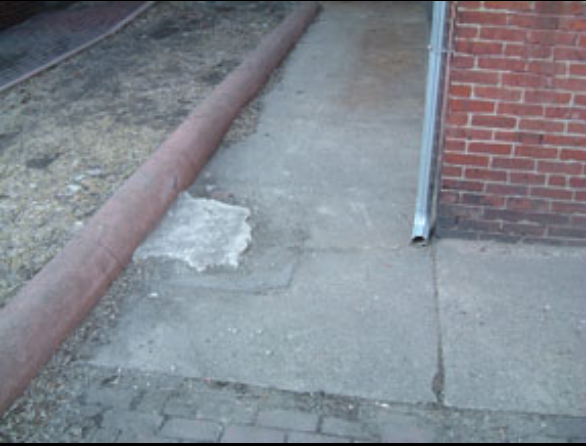
Covered up drain. Water now just pools.

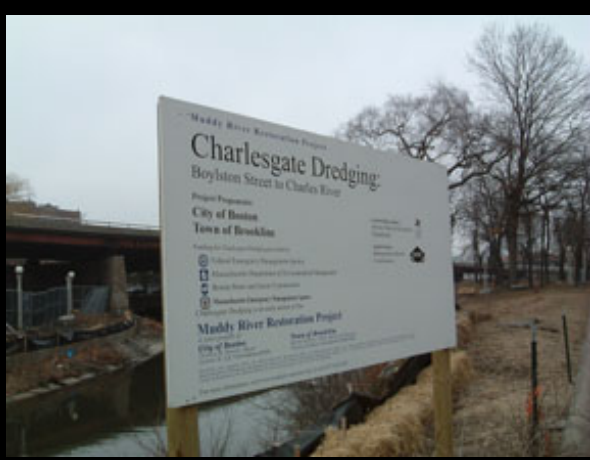
Charlesgate Dredging Information Sign

The current plan is a project that was recently begun and holds tremendous promise for the future of the area. The Muddy River Project (4) was created in 2002 to address problems with flooding and general lack of upkeep on the entire Muddy River and Fens area. Dredging was done throughout 2002 and continues into 2003. Signs can be seen along the river showing maps of the project and information about what the planners have in store for the area. One of the more important parts of the project is the Charlesgate dredging phase. In this phase of the project, the entire area leading up to and within the Charlesgate is completely renovated. The dredging process itself at the Charlesgate is currently underway and can be seen working almost every day. Unlike previous plans which merely widened the waterway or cleaned up garbage, the Muddy River Project plans to improve every aspect of the urban environment. After the dredging and cleanup, the old benches, walks, and lights will be removed and replaced with some actually useful park areas. Next there will be a 2 year landscape maintenance period while the project planners find out from the public what kind of amenities they want built. It is impossible to tell what sort of unforeseen effects this project may have on the Back Bay area, but the forecast in general looks good. Already, improvements in drainage and a general lack of flooding can be observed in the area. The site is not particularly pleasing to the eyes at the moment, but the projected vision has a great deal of potential for beauty and elegance; only time will tell.
